**Ozone Testing per ASTM F477 [2021]  
In chamber per ASTM D1149 [2018]**

Date: May 15, 2025  
Author: Adam Scarlett  
Report Number: ESP044366P

**Ozone Exposure Testing of Rubber  
Saudi Rubber Products Factory**

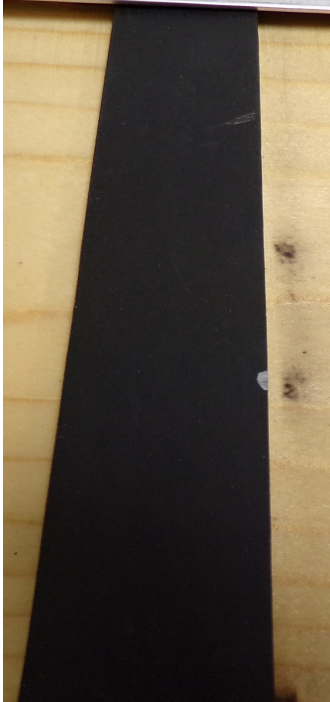
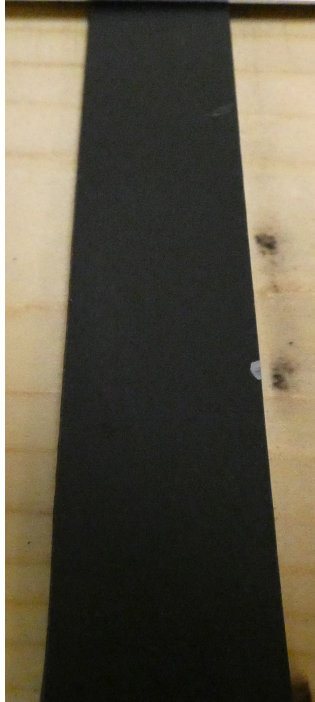
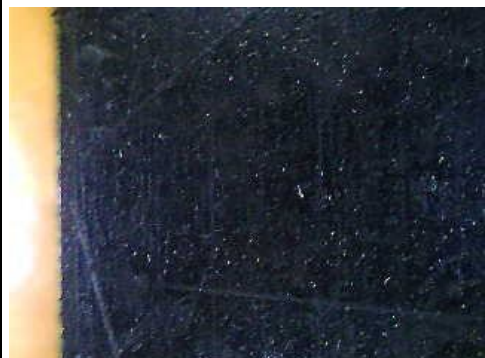
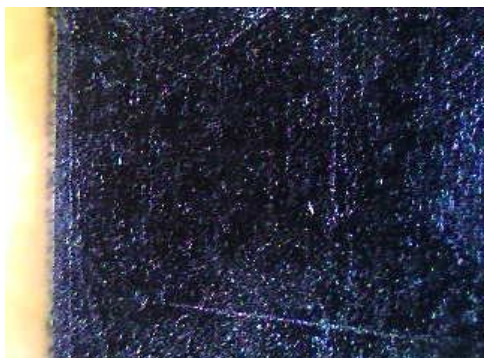
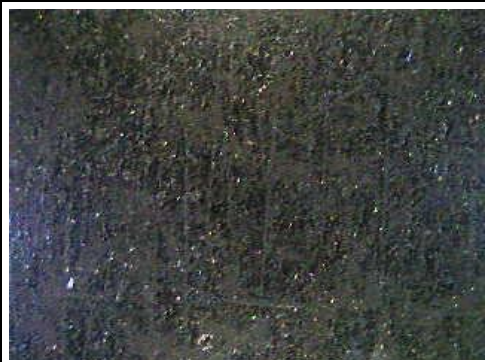
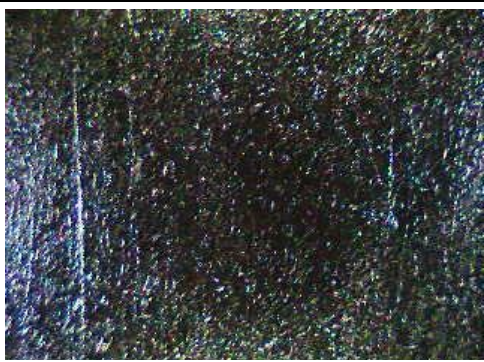
<p>SBR Sample 1</p>	<p>7x magnification Before Exposure</p>	<p>7x magnification After Exposure</p>	<p>No Visible Cracks  Complies</p>

ASTM D1149-18 Method B, Procedure B1		
Sample ID	Sample #	Results
Saudi Rubber Products Factory SBR Batch Code: SBR3SS25D17B11	1	No Visible Cracks  Complies
	2	
	3	
Saudi Rubber Products Factory EPDM Batch Code: EPDM3SS25D16B3	1	No Visible Cracks  Complies
	2	
	3

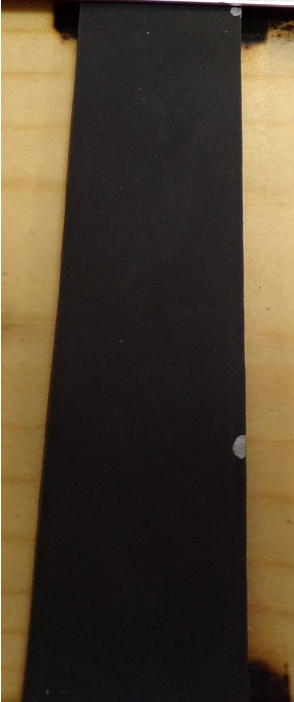
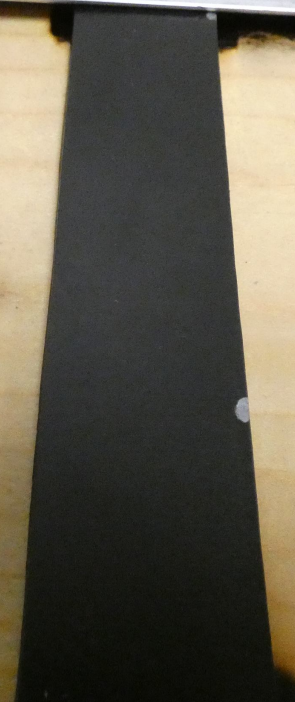
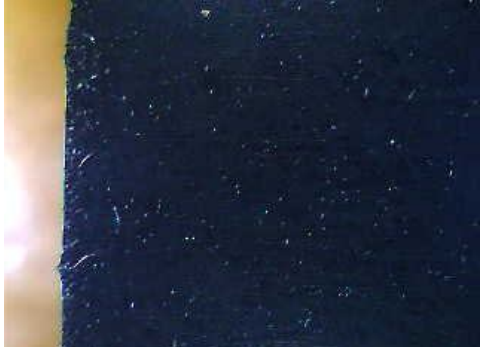
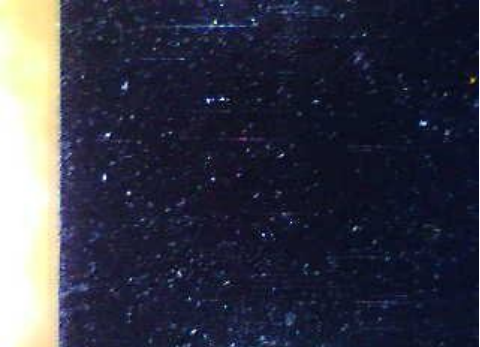
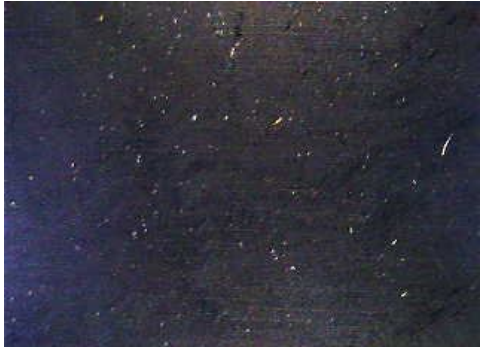
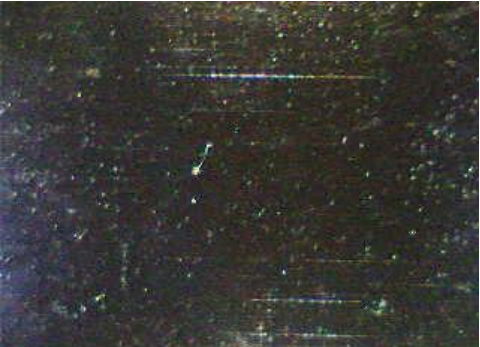
SBR Sample 2	7x magnification Before Exposure	7x magnification After Exposure	No Visible Cracks  Complies

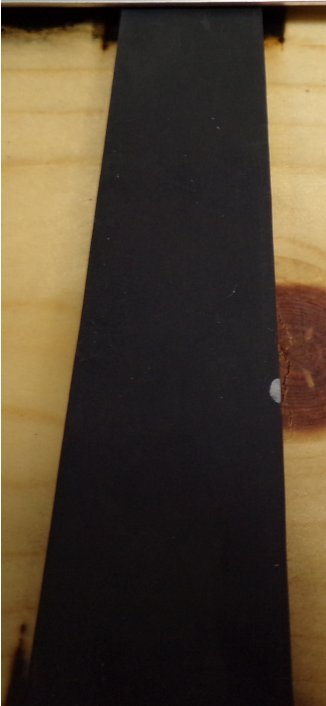
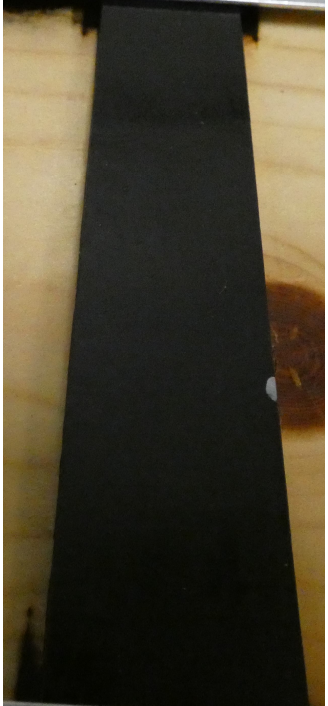
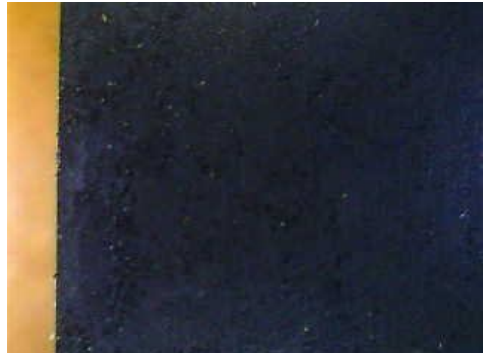
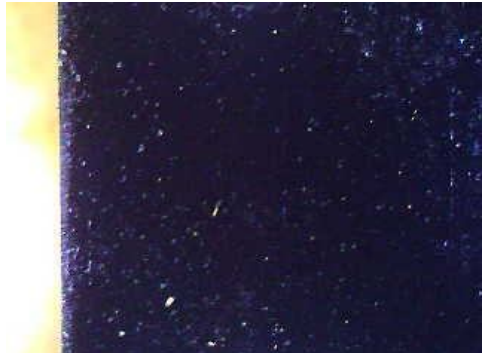
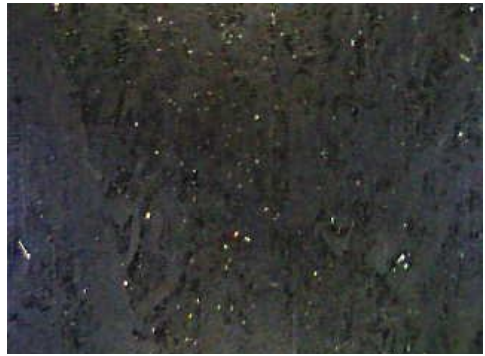
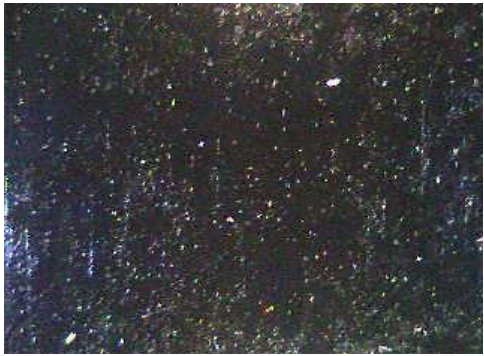
SBR Sample 3	7x magnification Before Exposure	7x magnification After Exposure	No Visible Cracks  Complies

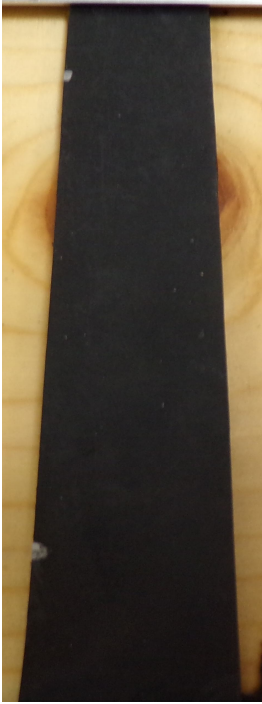
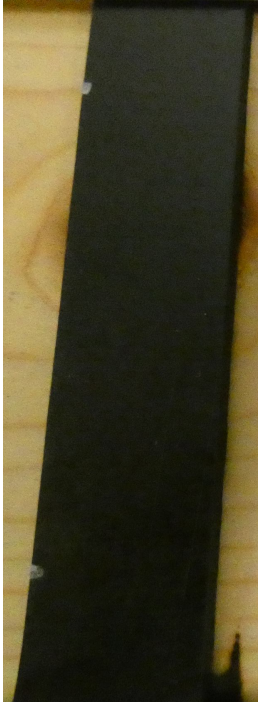
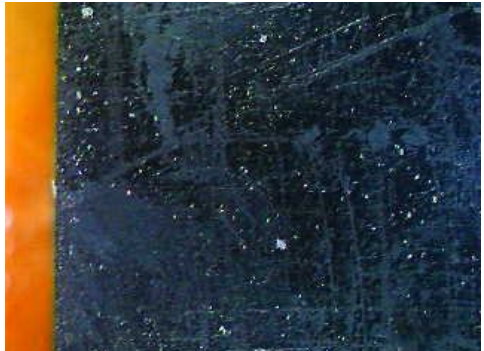
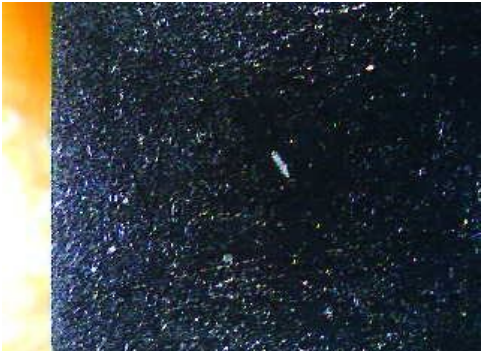
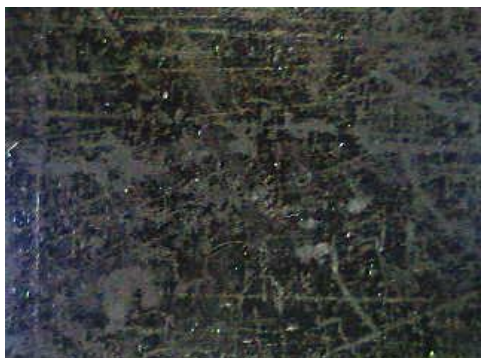
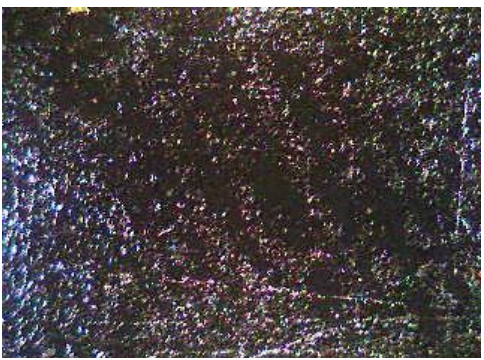
EPDM Sample 1	7x magnification Before Exposure	7x magnification After Exposure	No Visible Cracks  Complies

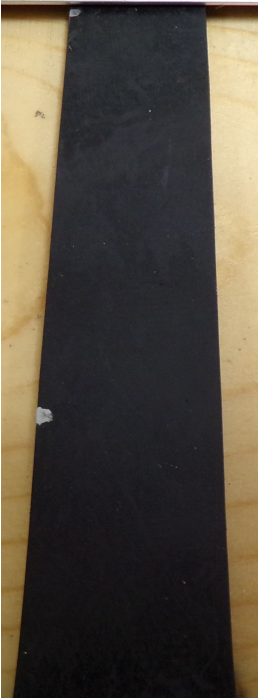
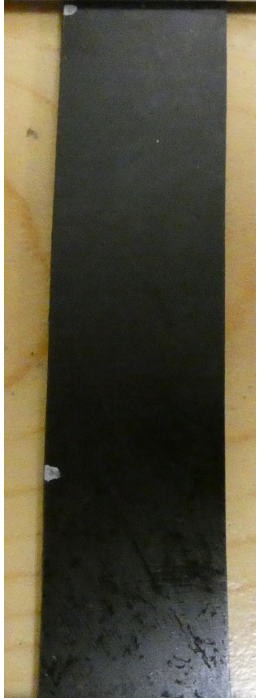
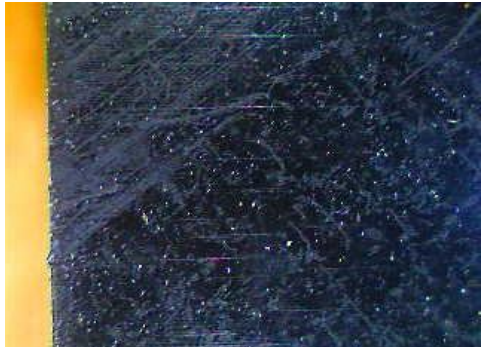
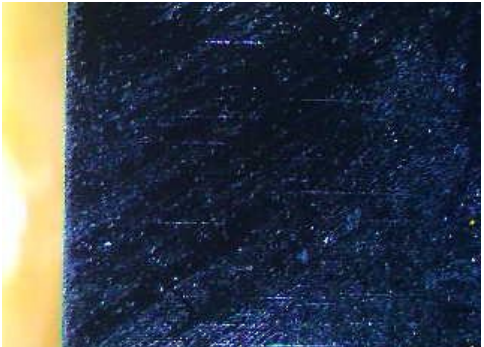
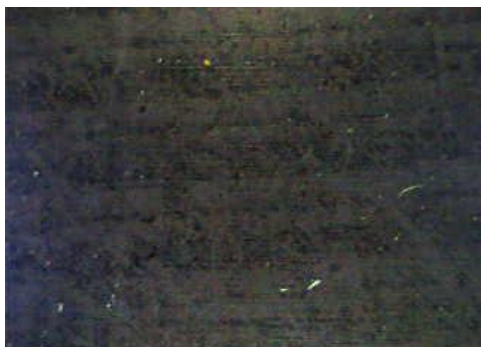
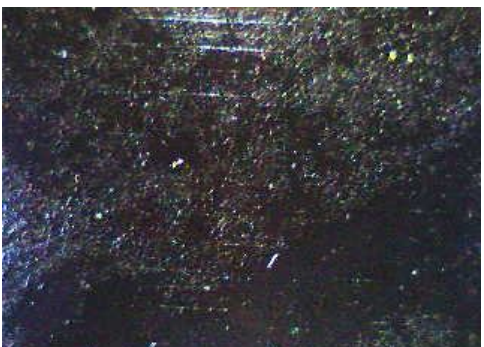
EPDM	7x magnification Before Exposure	7x magnification After Exposure	No Visible Cracks
Sample 2

Complies

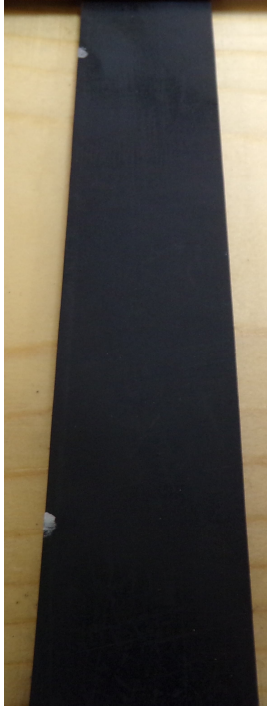
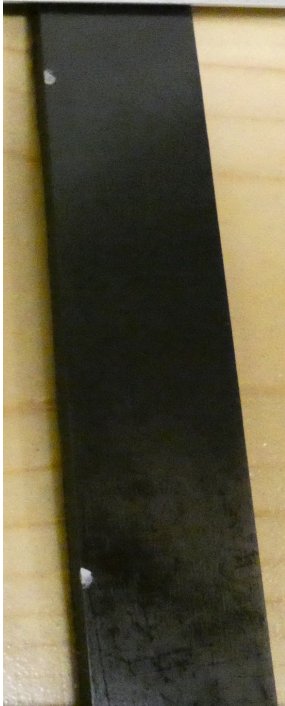
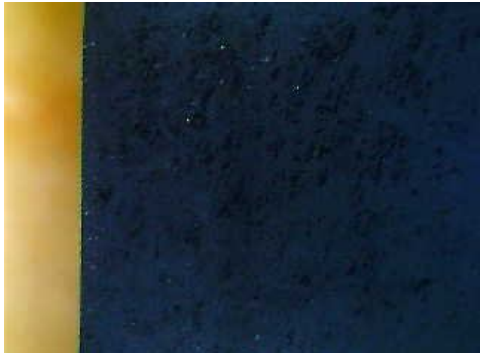
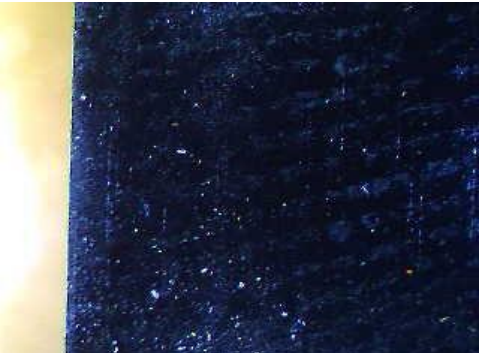
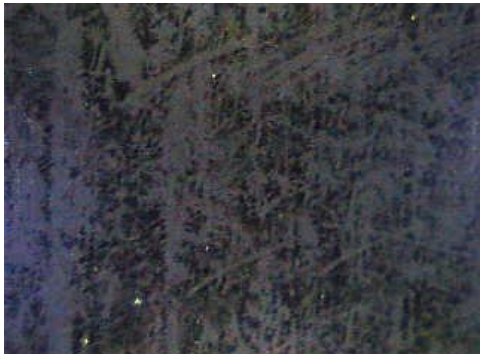
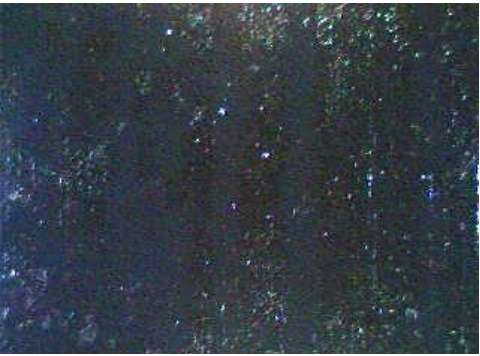
EPDM	7x magnification Before Exposure	7x magnification After Exposure	No Visible Cracks
Sample 3

Complies

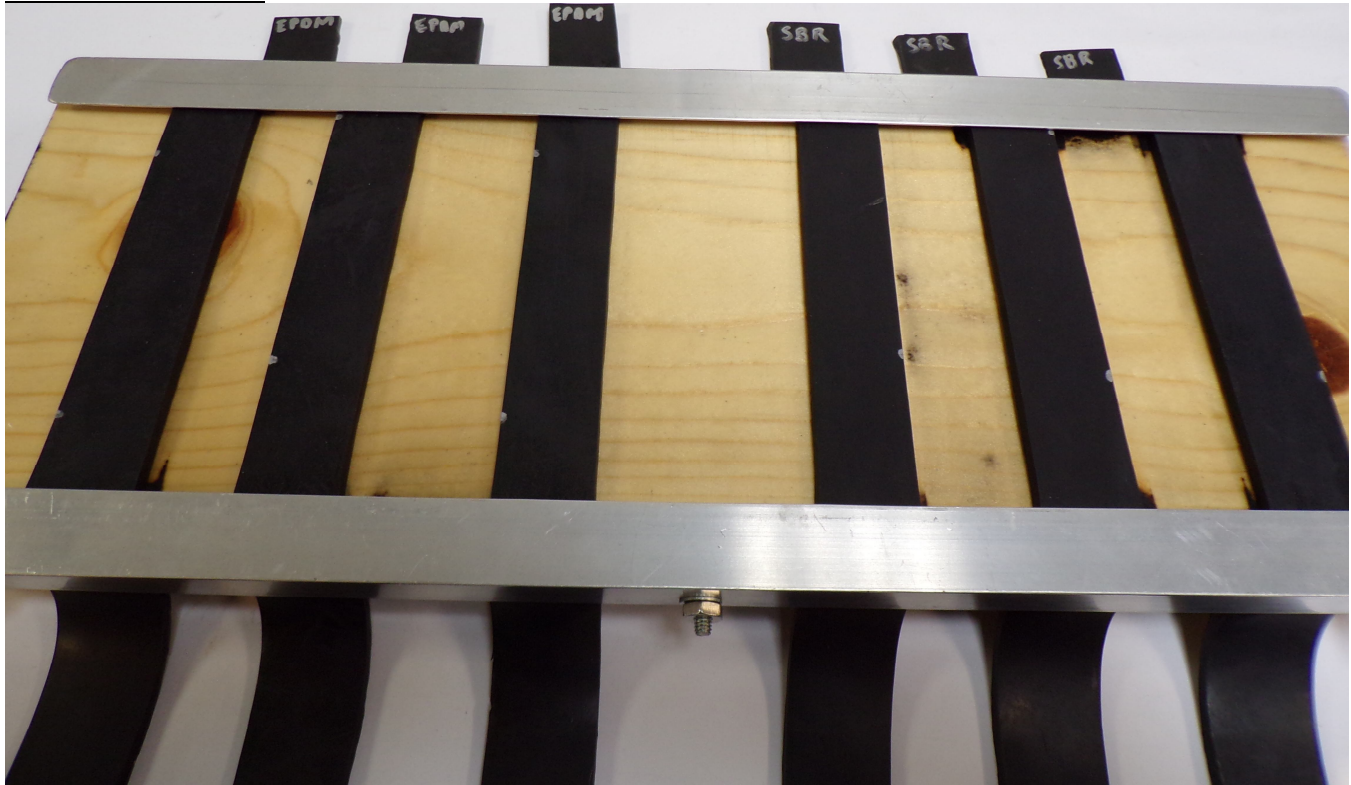
Samples Elongated 20%

Samples were tested in accordance with ASTM F477-21 section 7.9 requirements. Each strip was elongated 20% over a wooden block per ASTM D1149-18 Method B, Procedure B1. The elongated samples were conditioned in an ozone free environment for a minimum of 24 hours and then placed in the ozone chamber for 72 hours. The chamber was maintained at 50pphm ozone concentration by volume and 40 +/- 2 °C for the duration of exposure. At the conclusion of the exposure each specimen was evaluated at 7x magnification and checked for surface cracking. The results of this testing are documented below.
